## Kaiserstraße 7, Vienna

IEA – SHC Task 47

Renovation of Non-Residential Buildings towards Sustainable Standards

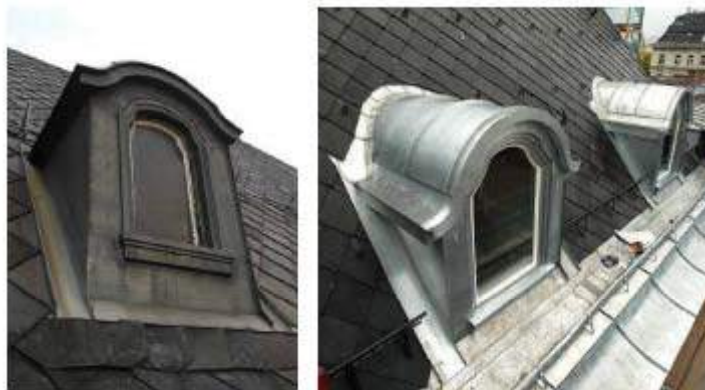
- *Historical dormer before and after renovation*

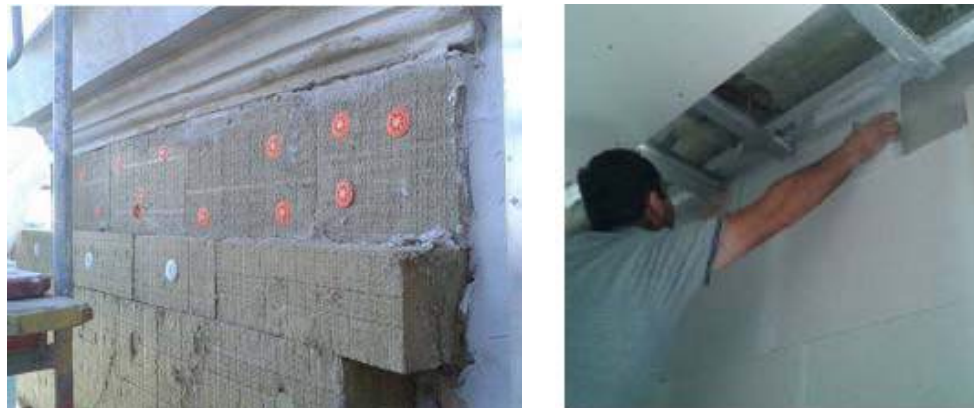
- *Insulation on fire-proof walls and interior insulation*

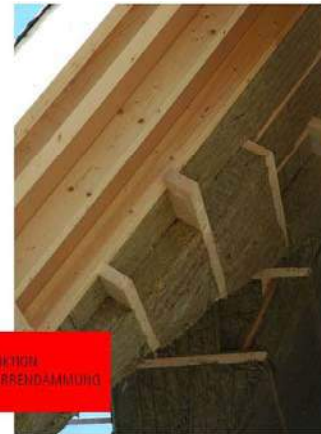
- Cross section of roof construction
- Insulation is to be mounted interior to sustain the roof bricks

**Roof construction** : U-value: 0,157 W/m<sup>2</sup>K

Gypsum cardboards	25 mm
Moisture barrier + air space	27 mm
Plywood	15 mm
Rock wool insulation	320 mm
Plywood	24 mm
Air space	80 mm
Lathing	30 mm
Roof brick (to be sustained)	
<b>Total</b>	<b>534 mm</b>

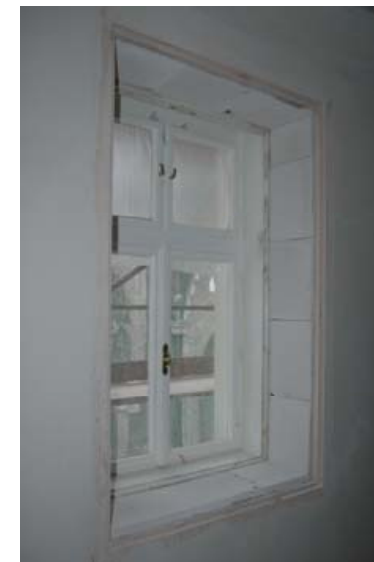
- Left: window construction in combination with interior insulation
- Right: Construction with 5cm calcium silicate panel (the accumulation of humidity in the wall construction is monitored)

**Wall construction** : U-value: 0,436 W/m<sup>2</sup>K

Filling	
Capillary-active mineral insulation	50 mm
Chalk-cement plastering	30 mm
Brick	∅ 600 mm
Chalk-cement plastering	30 mm
<b>Total</b>	<b>710 mm</b>

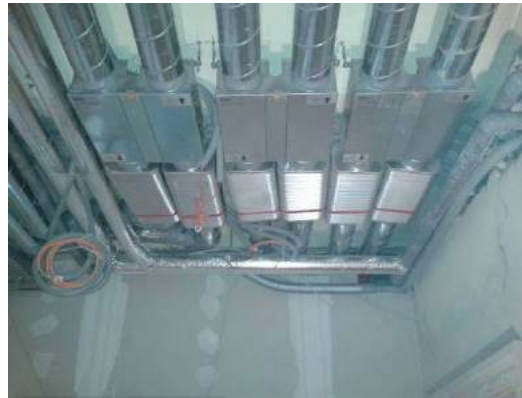
- Air ducts in the suspended ceiling with sound absorbers

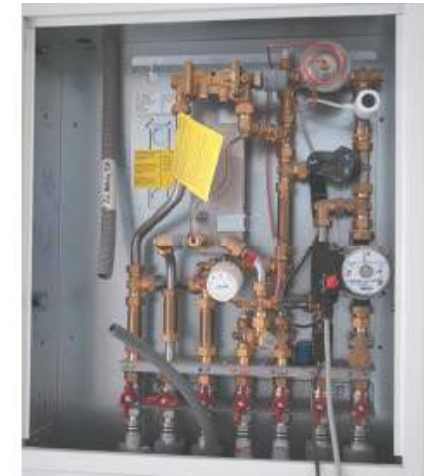
- Decentralized domestic warm water preparation

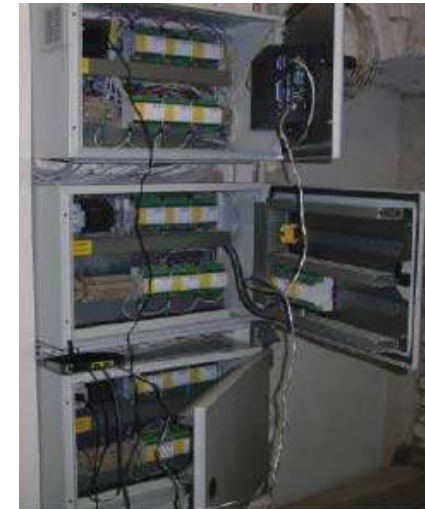
Monitoring hardware in a demonstration object:

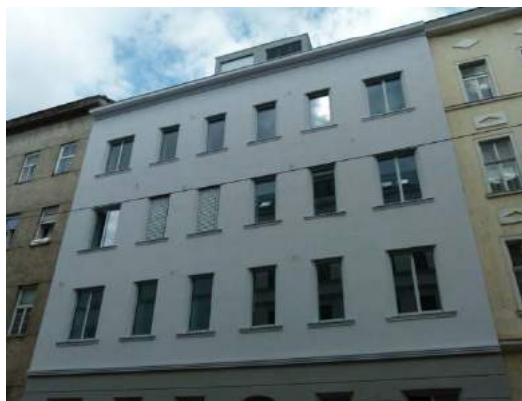
*Object Eberlgasse (Eberl Alley)*  
- *First modernization of a historic building to passive house standard*  
- *water/water heat pump*  
- *air ventilation system*
